Devon Diesel Society

Working Party Report – Aug 16

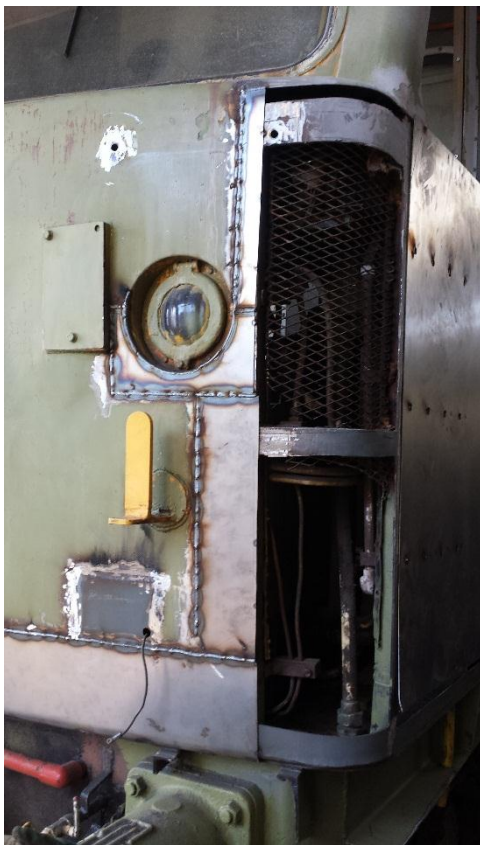
with various tasks undertaken and a general clean up and reorganisation of the PLOG also occurred. The bodywork repairs on D402 progressed well and No1 cab was completed and work at an advanced stage on No2 cab as the month closed. The photograph to the left is the driver's side of No1 cab and shows the level of work undertaken around the cab area and the amount of re-skinning work done, this was the same for all 4 corners of each cab. Volunteers had the weekend tasks of preparing the locomotive for further welding work whilst treating exposed areas of the locomotive that are not normally accessible to rust prevention coatings and painting in topcoat. The photograph below illustrates the levels of corrosion found on a 50-year-old locomotive and this was one of the better

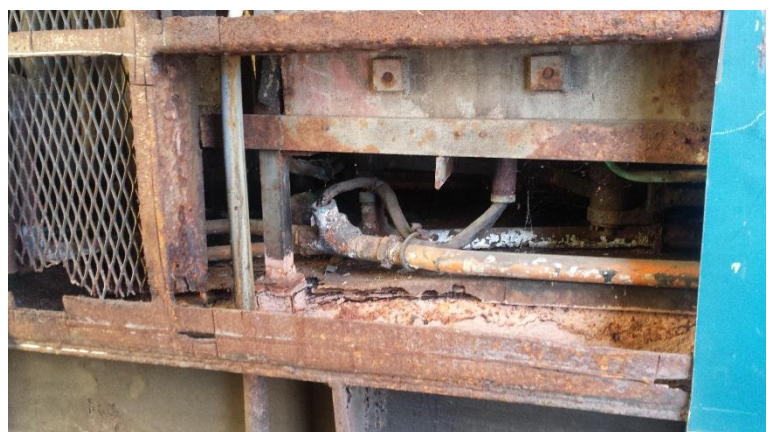
ones! The worst area of all was on the roof just above the gutters where it curved around the cab front, a considerable amount of rotten metal was removed from these areas. After the contractors had finished the body side welding work our volunteers then did a little preparation of the bodywork before it was treated to a coat of base green primer.
